**Flood Control Project Maintenance
Levee Inspections**

Fall 2018 Levee Maintenance Deficiency Summary Report

Sacramento River Basin

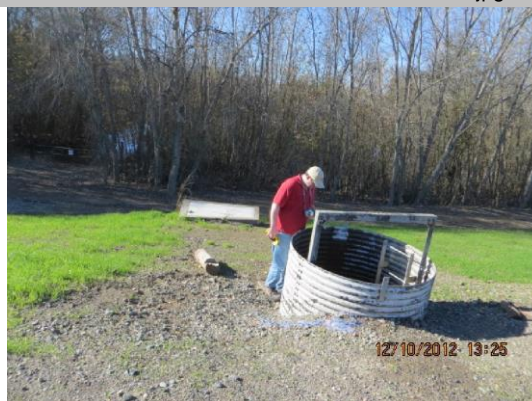
Photo 1 of 3 : UCIP_FA_2018_51753_47363.jpg

Comment Code					
Inspector Comment					
FS_ID:51753 DS_ID:17331 EP_NO: 1833 Repair Type: Non-Urgent Crossing Status: Found UCIP Comments: 4/20/2017 No leaky pipe marker present during this inspection but it appears that nothing has changed or was repaired since it was labled leaky in 2015. (DWR Sutter Yard-AFreitag)10/31/2016 Leaky pipe marker was not present at inspection but nothing appears to have changed with this crossing. (DWR Sutter Yard- AFreitag)6/15/2016 No changes made to this crossing. Leaky pipe marker still present.4/14/2016 Levee slightly caved in one side of surge box on WS4/2/2015 Leaks during high water. Distribution box plugged with cement concrete on LS. Other concrete box plugged with concrete on WS. New steel pipe (about 16 inch diameter) sleeved through CMP pipe. It is visible inside CMP riser.7/2/2014 Same as last inspection.12/19/2013 Same as last inspection.7/23/2013 Same as last inspection. FIELD_STRUCT_DESC: 42-inch corrugated metal irrigation pipe through the levee, 14.2 feet below the crown. 16-inch (approximate) pipe has been sleeved through the 42-inch corrugated metal pipe (CMP), with annular space pressure grouted. Pump structure on the waterside (WS) bank, not found in 2016. Concrete surge box at the WS toe. Slide gate in a CMP riser on the WS slope. Concrete distribution box on the landside (LS) across River Road. Phone number provided is 916-802-8293. (Permit No. 1833, 1953 - Carter). [Additional Reference(s): DWR Levee Log, 2002. USACE Sacramento O&M Manual 136, March 1960 (HLM 14.55)]. FS Date: 5/1/2017 10:35:31 AM

Waterside view: CMP riser with slide gate and surge box

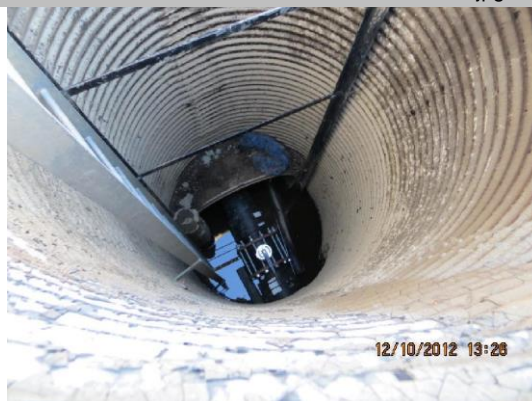
Photo 2 of 3 : UCIP_FA_2018_51753_47362.jpg

UCIP Comments: 4/20/2017 No leaky pipe marker present during this inspection but it appears that nothing has changed or was repaired since it was labled leaky in 2015. (DWR Sutter Yard- AFreitag)10/31/2016 Leaky pipe marker was not present at inspection but nothing appears to have changed with this crossing. (DWR Sutter Yard- AFreitag)6/15/2016 No changes made to this crossing. Leaky pipe marker still present.4/14/2016 Levee slightly caved in one side of surge box on WS4/2/2015 Leaks during high water. Distribution box plugged with cement concrete on LS. Other concrete box plugged with concrete on WS. New steel pipe (about 16 inch diameter) sleeved through CMP pipe. It is visible inside CMP riser.7/2/2014 Same as last inspection.12/19/2013 Same as last inspection.7/23/2013 Same as last inspection.

Waterside view: new steel pipe sleeved through CMP pipe.

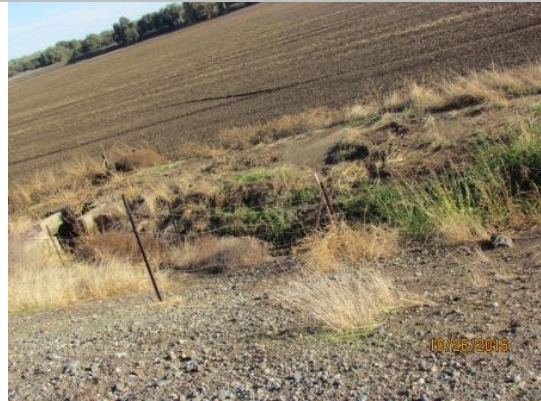
Photo 1 of 1 : FA_2018_ST0003_264_71_20180905_00015.jpg

LM Start	15.17	Rating **	M	Issue No.	71
LM End	15.48	Issue Type +	En	Location *	LS
Category	Earthen Levee			GPS Latitude/Longitude	
				Start	End
Item	Encroachments			39.330578 °	39.333842 °
				-122.018485 °	-122.022225 °
DWR ID	DWR_ST0003_01_f_2016_71				
Comment Code					
DT : Ditch					
Inspector Comment

View of a ditch along the landside toe.

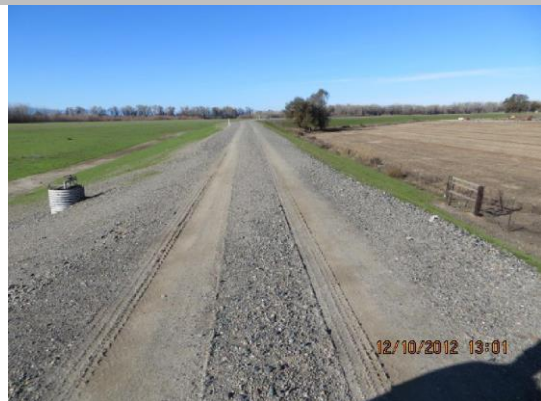
Photo 1 of 3 : UCIP_FA_2018_51755_47371.jpg

Comment Code					
Inspector Comment					
FS_ID:51755 DS_ID:17333 EP_NO: 9506 Repair Type: Non-Urgent Crossing Status: Found UCIP Comments: 4/20/2017 Both pipe ends were underwater during site visit but it appears to be in good condition. (DWR Sutter Yard-AFreitag)10/31/2016 Minor erosion caused by rain runoff starting at the top of the WS headwall. REst of crossing appears in good condition. (DWR Sutter Yard- AFreitag)6/15/2016 Both pipe ends were underwater but appear to be in good condition.4/2/2015 Pipe and ditches were full of water. Everything seemed to be in good shape.Water full on inlet and outlet of the structure.7/2/2014 Same as last inspection.12/19/2013 Same as last inspection.7/23/2013 Same as last inspection. FIELD_STRUCT_DESC: 24-inch irrigation pipe of an unknown material through the levee, 16.5 feet below the crown. Pump in the floodway. Irrigation transfer ditch on the waterside (WS) to concrete surge box at the WS toe. Slide gates in a corrugated metal pipe (CMP) riser on the WS slope. Discharges into a concrete distribution box at the landside (LS) toe. (Automatic Board Order (ABO) issued as Permit No. 9506, 1974 - Carter). [Additional Reference(s): DWR Levee Log, 2002. USACE Sacramento O&M Manual 136, March 1960 (HLM 15.46)]. FS Date: 5/1/2017 10:38:21 AM

Crown view: overview (both sides of the levee)

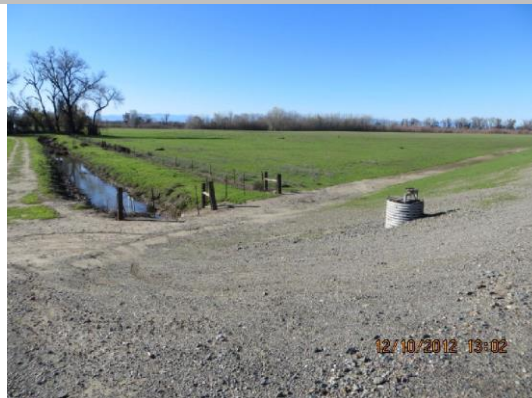
Photo 2 of 3 : UCIP_FA_2018_51755_47370.jpg

Waterside view: CMP riser, inlet box and water transfer ditch

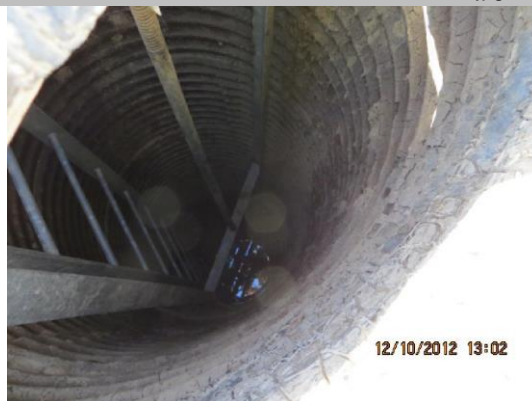
Photo 3 of 3 : UCIP_FA_2018_51755_47369.jpg

Waterside view: inside CMP riser

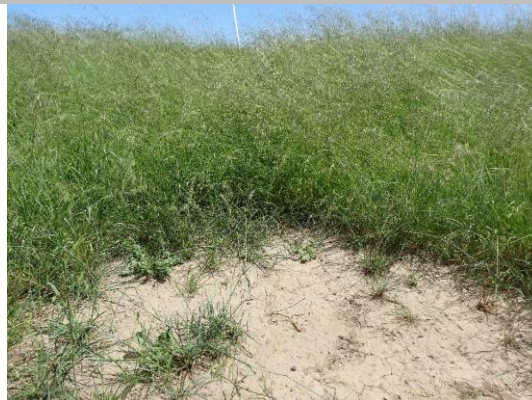
Photo 3 of 3 : UCIP_FA_2018_51759_75098.jpg

FS_ID:51759
DS_ID:17337
EP_NO: N/A
Repair Type: Non-Urgent
Crossing Status: Found
UCIP Comments: 4/20/2017 Abandoned- needs to be done so properly. (DWR Sutter Yard- A Freitag)11/1/2016 Abandoned. Pipe is buried and not visible but a white marker on WS shoulder shows its location. (DWR Sutter Yard- A Freitag)6/15/2016 Pipe was dug up and internally cleaned and camera inspected on 11/19/2015 by Nor-Cal Pipeline Services. Pipe section through the levee is 88ft long and showed signs of rusting but no holes or other deterioration was found. The WS flap gate was broken during excavation but doesn't pose an issue as the pipe was capped and reburied until further abandonment can be achieved. Unfortunately the pipe was not photographed when exposed.4/14/2016 Same as last inspection.4/2/2015 Unable to locate. Pipe has been selected to be dug up and internally camera inspected.7/2/2014 Unable to locate.12/19/2013 Unable to locate.7/23/2013 Same as last inspection. Unable to locate.

Looking up WS slope: bare spot where pipe was previously excavated, video inspected, and backfilled.

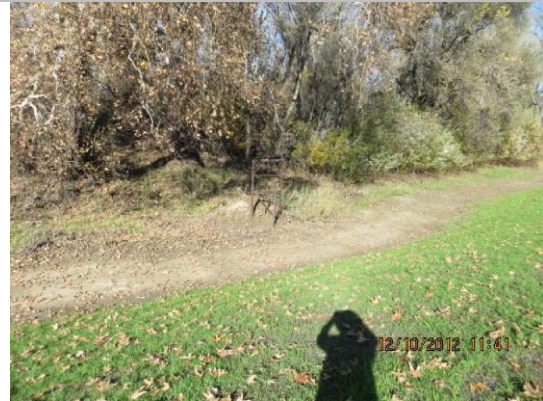
Photo 1 of 3 : UCIP_FA_2018_51760_47380.jpg

Waterside view: overview of slide gate

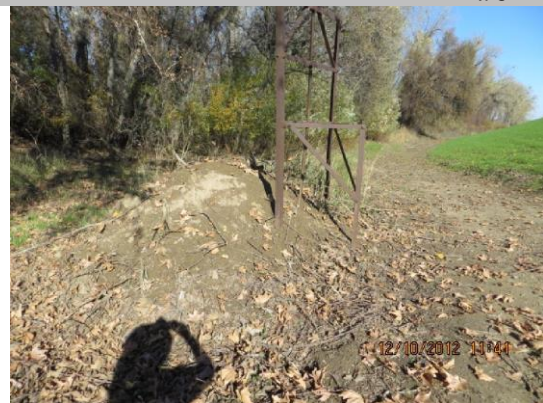
Photo 2 of 3 : UCIP_FA_2018_51760_47379.jpg

Waterside view: slide gate on steel structure

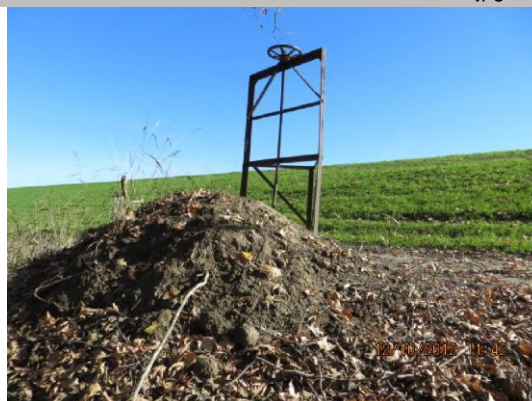
Photo 3 of 3 : UCIP_FA_2018_51760_47378.jpg

Waterside view: silt and debris in front of slide gate

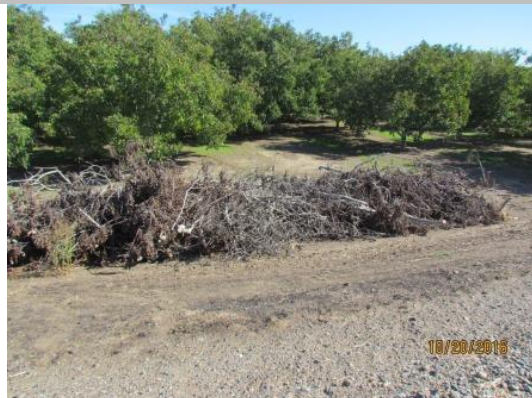
Photo 1 of 1 : FA_2018_ST0003_264_65_20180905_00012.jpg

LM Start	17.51	Rating **	M	Issue No.	65
LM End	17.51	Issue Type +	En	Location *	LS
Category	Earthen Levee			GPS Latitude/Longitude	
				Start	End
Item	Encroachments			39.352615 °	39.352615 °
				-122.009247 °	-122.009247 °
DWR ID	DWR_ST0003_01_f_2016_65				
Comment Code					
PR : Prunings					
Inspector Comment					
Remove prunings from the landside toe.

View of the prunings along the landside toe.

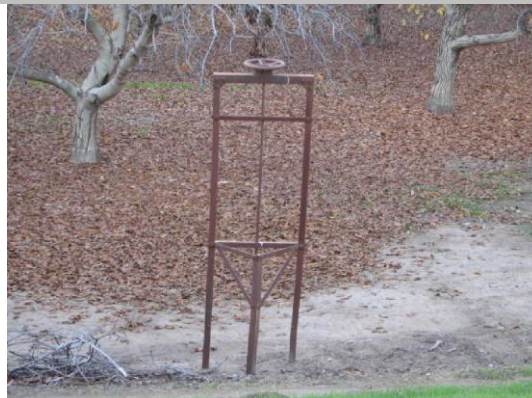
Photo 2 of 3 : UCIP_FA_2018_51762_47386.jpg

LM Start	17.58	Rating **	M	Issue No.	186 (cont)
LM End	17.58	Issue Type +	Ma	Location *

Waterside view: slide gate steel structure

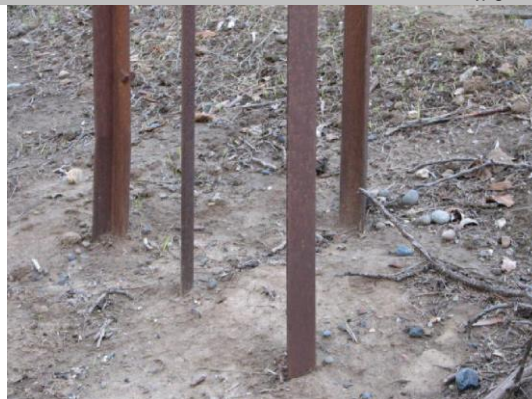
Photo 3 of 3 : UCIP_FA_2018_51762_47385.jpg

Waterside view: buried slide gate

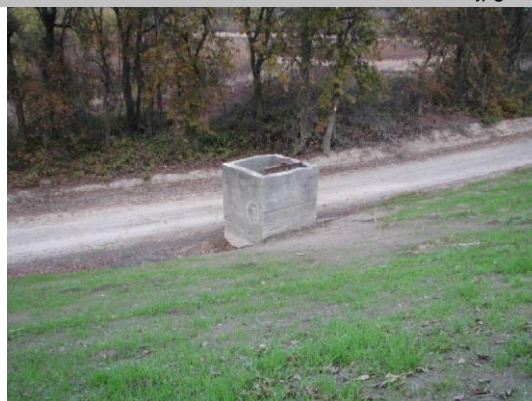
Photo 1 of 3 : UCIP_FA_2018_51766_47394.jpg

FS_ID:51766
DS_ID:17343
EP_NO: 9502
Repair Type: Non-Urgent
Crossing Status: Found
UCIP Comments: 4/20/2017 Abandoned- needs to be done properly.
(DWR Sutter Yard- AFreitag)11/1/2016 Abandoned. (DWR Sutter Yard- AFreitag)6/3/2016 Abandoned crossing.4/2/2015 Same as last inspection. Vertical pump on bank not found as bank is not accessible. An abandoned electrical switch found on waterside. Landside distribution box is filled with debris and soil. Crossing appears abandoned and should be verified as having been done so properly.

LM Start	18.19	Rating **	M	Issue No.	189 (cont)
LM End	18.19	Issue Type +	En	Location *

Waterside view: overview of gate riser

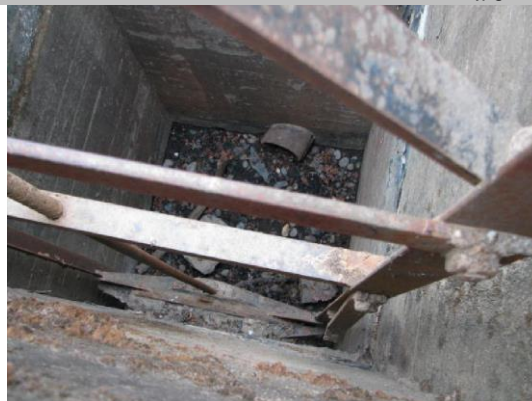
Photo 2 of 3 : UCIP_FA_2018_51766_47392.jpg

Waterside view: inside gate riser

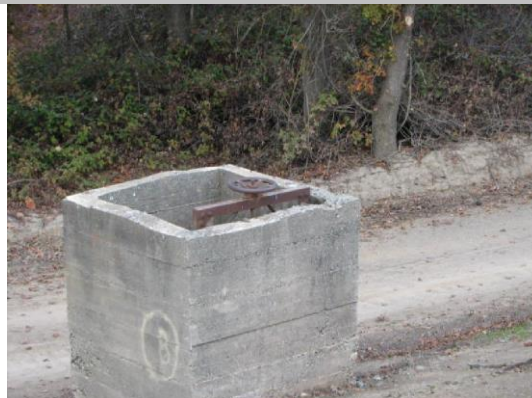
Photo 3 of 3 : UCIP_FA_2018_51766_47391.jpg

Waterside view: concrete gate riser

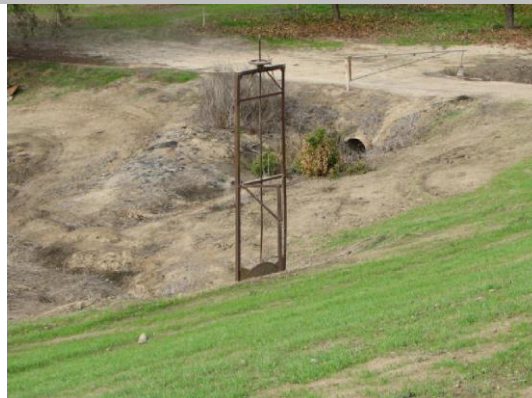
Photo 1 of 3 : UCIP_FA_2018_51770_47399.jpg

LM Start	18.61	Rating **	A/W	Issue No.	191 (cont)
LM End	18.61	Issue Type +	Ma	Location *

Waterside view: overview of sliding gate structure

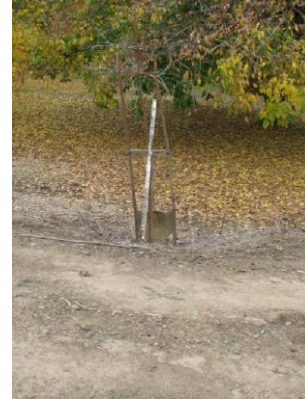
Photo 1 of 3 : UCIP_FA_2018_51771_47442.jpg

LM Start	18.70	Rating **	A/W	Issue No.	192 (cont)
LM End	18.70	Issue Type +	Ma	Location *

Waterside view: overview of slide gate structure

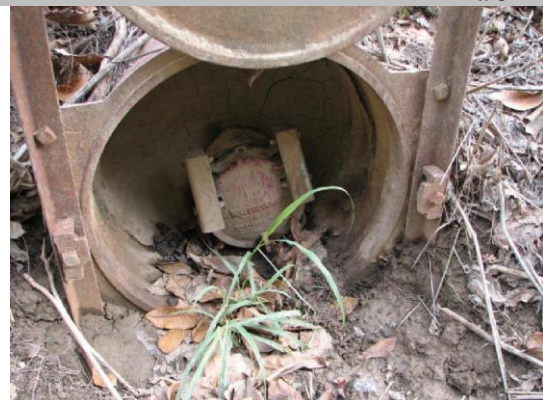
Photo 2 of 3 : UCIP_FA_2018_51771_47441.jpg

Waterside view: 8-inch pipe inside 24-inch CMP

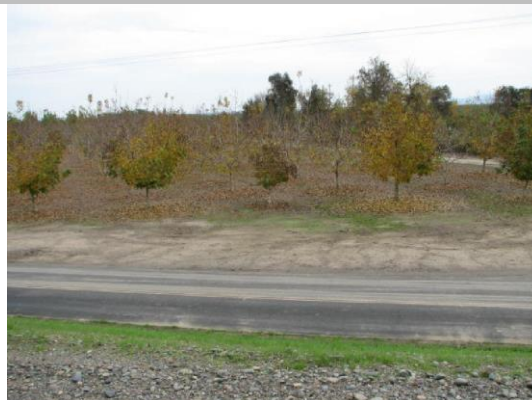
Photo 2 of 3 : UCIP_FA_2018_51773_47446.jpg

Landside view: overview (no pipes)

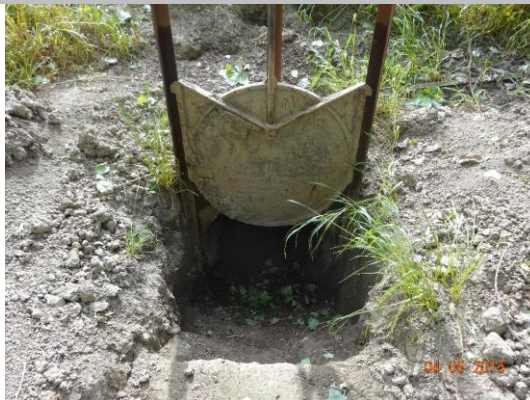
Photo 3 of 3 : UCIP_FA_2018_51773_73781.jpg

WS pipe end and screw gate

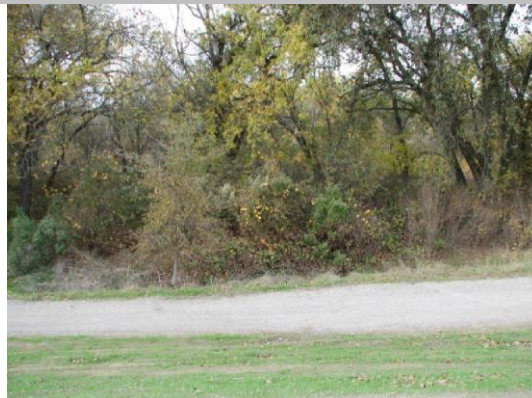
Photo 1 of 3 : UCIP_FA_2018_51775_47449.jpg

Comment Code					
Inspector Comment					
FS_ID:51775					
DS_ID:17487					
EP_NO: N/A					
Repair Type: Non-Urgent					
Crossing Status: Found					
UCIP Comments: 4/20/2017 Abandoned- needs to be done so properly. (DWR Sutter Yard- A Freitag)11/1/2016 Abandoned.(DWR Sutter Yard- A Freitag)6/3/2016 Abandoned crossing.4/2/2015 Same as last inspection. Slide Gate WS not found. An abandoned pump and steel pipe found on WS. A 6 ft x 8 ft concrete distribution box with a CMP found on LS. Box filled with soil. An abandoned crossing.7/2/2014 Same as last inspection.12/19/2013 Same as last inspection.7/24/2013 Same as last inspection.					
FIELD_STRUCT_DESC: *ABANDONED* 36-inch corrugated metal drainage pipe through the levee, invert 21.7 feet below the crown.					
Abandoned pump and steel pipe found on the waterside (WS). 6 foot by 8 foot concrete distribution box with the 36-inch corrugated metal pipe found on the landside (LS). [Additional Reference(s): USACE Sacramento O&M Manual 136, March 1960 (HLM 19.61)].

LM Start	19.55	Rating **	M	Issue No.	194 (cont)
LM End	19.55	Issue Type +	Ma	Location *

Waterside view: overview

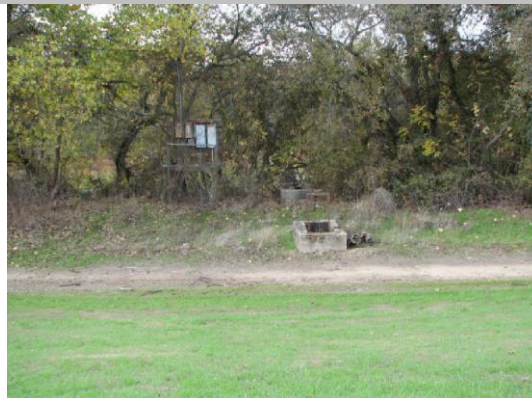
Photo 1 of 3 : UCIP_FA_2018_51776_47459.jpg

FS_ID:51776
DS_ID:17370
EP_NO: 9496
Repair Type: Non-Urgent
Crossing Status: Found
UCIP Comments: 4/20/2017 Abandoned- needs to be done properly. (DWR Sutter Yard- A Freitag) 11/1/2016 Abandoned. (DWR Sutter Yard- A Freitag) 6/3/2016 Abandoned crossing 4/2/2015 Same as last inspection. Only one pump found on WS. An abandoned surge box found on WS and pipe is grouted with cement. Two 16-inch steel pipe found on pump station along with two electrical conduits. A concrete distribution box found on LS with 20-inch CMP. Appears abandoned crossing. 7/2/2014 Same as last inspection. 12/19/2013 Same as last inspection. 7/24/2013 Same as last inspection.
FIELD_STRUCT_DESC: *ABANDONED* 20-inch corrugated metal irrigation pipe through the levee, 19.8 feet below the crown. (Not 24-inch pipe, as stated in the O&M Manual, Automatic Board Order, and Levee Log). Two vertical pumps on a pile structure on the waterside (WS) bank (one pump found in 2015). Slide gate in a concrete surge box on the waterside (WS) berm. Discharges into a concrete distribution box on the landside (LS) across the county road. Switch board on the platform on the WS bank. (Automatic Board Order (ABO) issued as Permit No. 9496, 1974 - Womble). [Additional Reference(s): DWR Levee Log, 2002. USACE Sacramento O&M Manual 136, March 1960 (HLM 20.05)].

LM Start	19.97	Rating **	M	Issue No.	195 (cont)
LM End	19.97	Issue Type +	En	Location *

Waterside view: overview

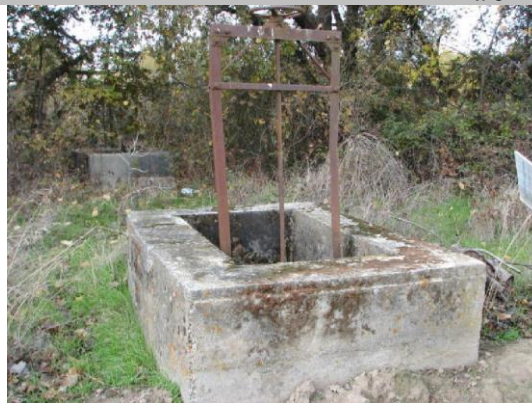
Photo 2 of 3 : UCIP_FA_2018_51776_47457.jpg

Waterside view: gate riser with slide gate

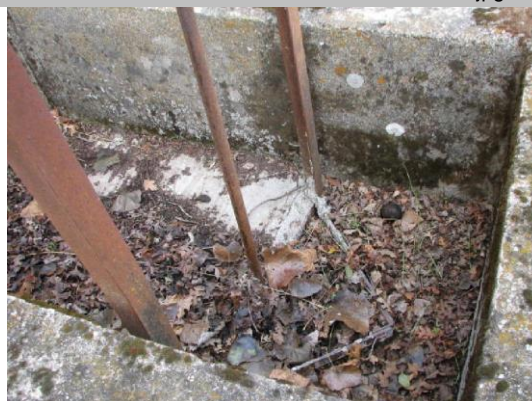
Photo 3 of 3 : UCIP_FA_2018_51776_47456.jpg

Waterside view: abandoned pipe with cement grouting

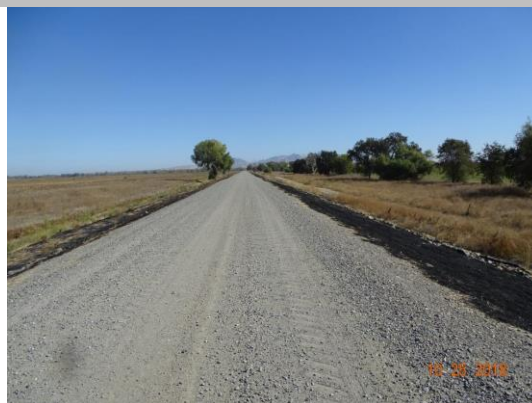
Photo 1 of 1 : FA_2018_ST0003_265_3_20181102_00004.jpg

LM Start	0.37	Rating **	A	Issue No.	3
LM End	0.37	Issue Type +	Ma	Location *	LS
Category	Earthen Levee			GPS Latitude/Longitude	
				Start	End
Item	Vegetation			39.231415 °	39.231415 °
				-121.989060 °	-121.989060 °
DWR ID	DWR_ST0003_02_f_2018_3				
Comment Code					
V1 : Control annual grass and weeds on the levee slopes and easements.					
Inspector Comment					
The vegetation was burned off of both slopes.

View of no vegetation on both slopes.

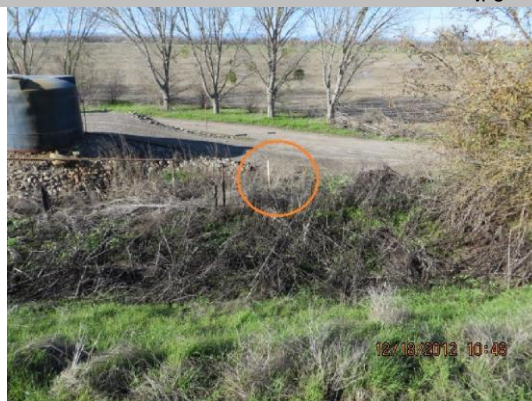
Photo 1 of 3 : UCIP_FA_2018_49161_47480.jpg

LM Start	1.20	Rating **	M	Issue No.	12 (cont)
LM End	1.20	Issue Type +	En	Location *

Landside view: overview gasoline indicator

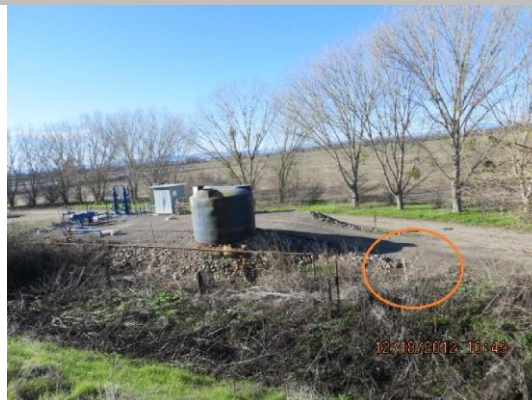
Photo 2 of 3 : UCIP_FA_2018_49161_47479.jpg

Landside view: overview gasoline indicator

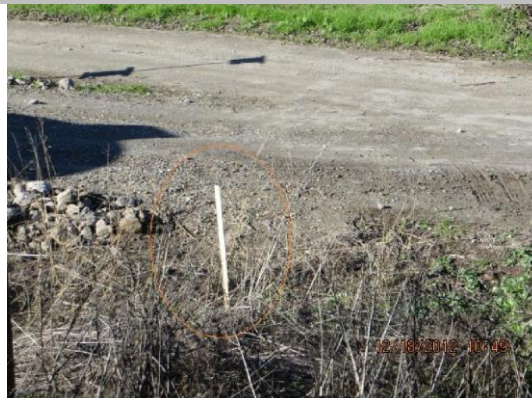
Photo 3 of 3 : UCIP_FA_2018_49161_47478.jpg

Comment Code						
Inspector Comment						
FS_ID:49161 DS_ID:17531 EP_NO: 13534 Repair Type: Non-Urgent Crossing Status: Indicator Found UCIP Comments: 6/3/2016 Crossing appears to be in good condition.4/6/2015 Same as last inspection. May need to add more substantial gasoline markers.7/7/2014 Same as last inspection.12/19/2013 Same as last inspection.7/22/2013 Same as last inspection. FIELD_STRUCT_DESC: 2.5-inch asphalt coated steel gas pipeline through the levee, 2.5 feet below the crown. A gas line marker found on the landside (LS). (Permit No. 13534, 1982 - Texaco, Incorporated). [Additional Reference(s): DWR Levee Log, 2002]. FS Date: 6/16/2016 10:00:15 AM

Landside view: gasline indicator

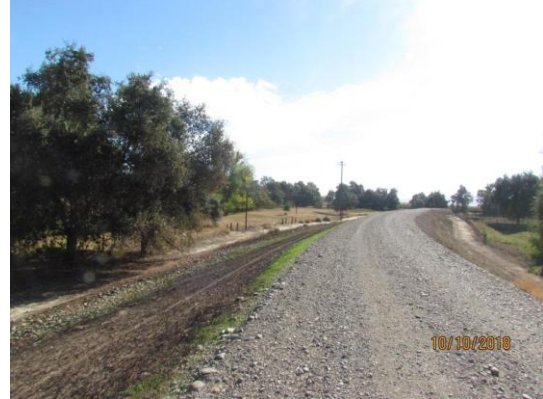
Photo 1 of 1 : FA_2018_ST0003_267_1_20181105_00001.jpg

LM Start	0.10	Rating **	A	Issue No.	1
LM End	0.10	Issue Type +	Ma	Location *	LS
Category	Earthen Levee			GPS Latitude/Longitude	
				Start	End
Item	Vegetation			39.337763 °	39.337763 °
				-122.020342 °	-122.020342 °
DWR ID	DWR_ST0003_04_f_2018_1				
Comment Code					
V1 : Control annual grass and weeds on the levee slopes and easements.					
Inspector Comment					
The vegetation has been removed from both slopes.

View of no vegetation on both slopes.

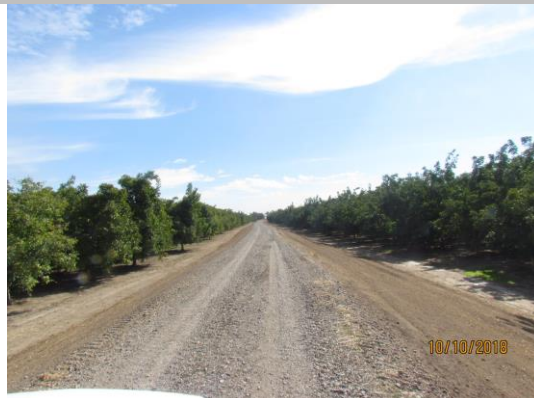
Photo 1 of 1 : FA_2018_ST0003_268_2_20181105_00003.jpg

LM Start	0.35	Rating **	A	Issue No.	2
LM End	0.35	Issue Type +	Ma	Location *	LS
Category	Earthen Levee			GPS Latitude/Longitude	
				Start	End
Item	Vegetation			39.343242 °	39.343242 °
				-122.016578 °	-122.016578 °
DWR ID	DWR_ST0003_05_f_2018_2				
Comment Code					
V1 : Control annual grass and weeds on the levee slopes and easements.					
Inspector Comment					
The vegetation has been removed from both slopes.

View of no vegetation on both slopes.

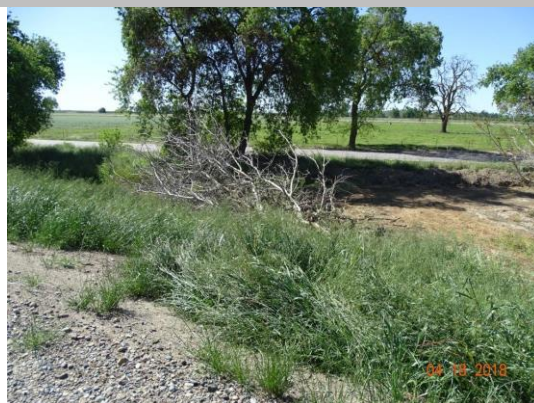
Photo 1 of 1 : FA_2018_ST0003_268_5_20180905_00002.jpg

LM Start	0.71	Rating **	M	Issue No.	5
LM End	0.71	Issue Type +	En	Location *	WS
Category	Earthen Levee			GPS Latitude/Longitude	
				Start	End
Item	Encroachments			39.341167 °	39.341167 °
				-122.010412 °	-122.010412 °
DWR ID	DWR_ST0003_05_s_2018_5				
Comment Code					
PR : Prunings					
Inspector Comment					
Remove the prunings from the waterside toe.

View of the prunings along the waterside toe.

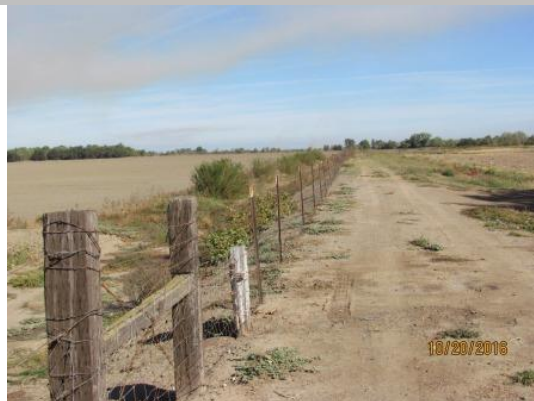
Photo 1 of 1 : FA_2018_ST0003_268_1_20180905_00001.jpg

LM Start	1.59	Rating **	M	Issue No.	1
LM End	2.18	Issue Type +	En	Location *	CR
Category	Earthen Levee			GPS Latitude/Longitude	
				Start	End
Item	Encroachments			39.335953 °	39.336852 °
				-121.995807 °	-121.984934 °
DWR ID	DWR_ST0003_05_s_2016_1				
Comment Code					
FE : Fence					
Inspector Comment

View of the fence obstructing access.
